## THE PITTODRIE ESTATE 'BEDE HOUSE' EXCAVATIONS

Iain Ralston and Colin Shepherd

## THE ARCHAEOLOGICAL ASSESSMENT

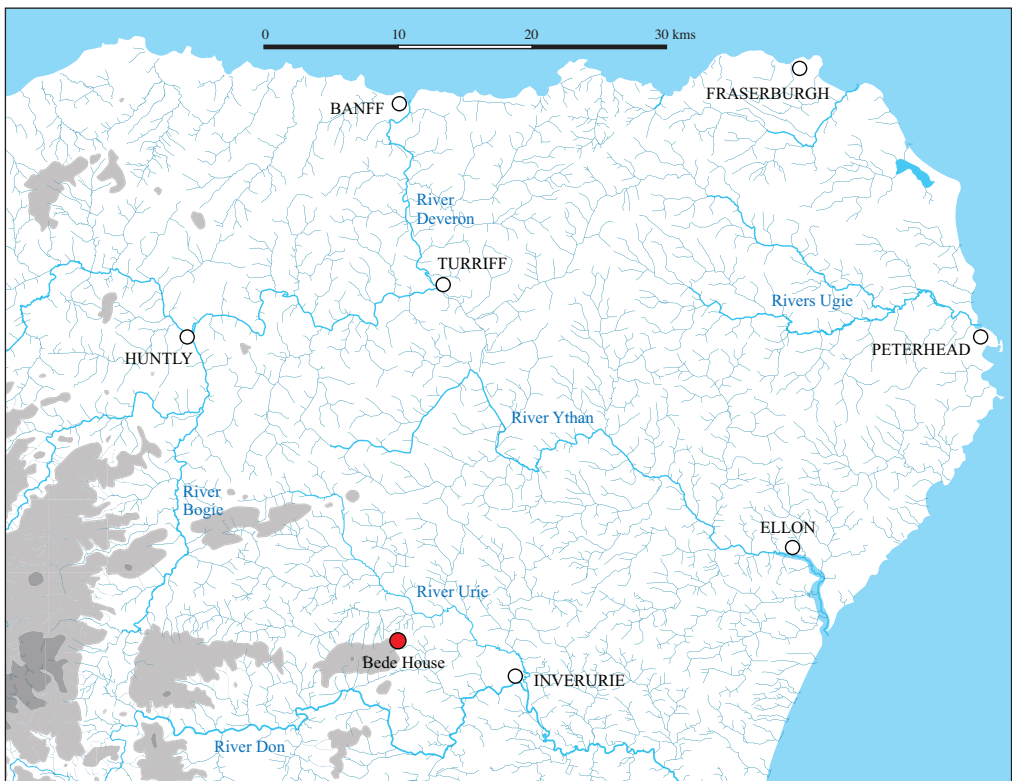
*Figure 1. Location of the Pittodrie Bede House.*

In Alexander McConnochie's book titled 'Bennachie' (1890, 27) he writes: "... a little above which may be seen the foundations of the "Bede House", or houses rather, for there are said to have been several of them, very small, each with its own little "yardie"'. The 'Bede House', as shown on the 1st edition Ordnance Survey, is situated within 'Bedehouse Wood', south-west of Pittodrie House on the east side of Bennachie at co-ordinates NJ 6933 2356.

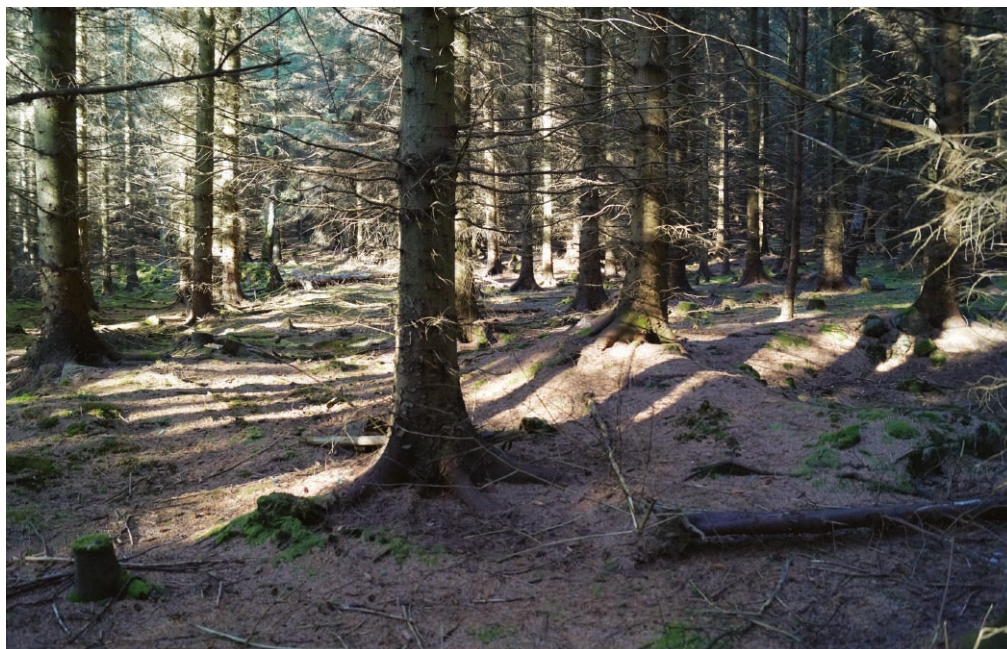
Photo 1. View of the 'Bede House' site before excavation.

Locating the Bede House on the ground was aided by using the 'dry-stane' dykes that are shown on the 1st edition OS map and which still stand to a considerable height in places. When first visited by the author, the site was found to exist mainly as low earthworks with only occasional stones emerging in places to suggest the possibility of walls lying beneath. McConnochie mentions these as "foundations" (*ibid*). But, prior to our fieldwork the site could easily have been walked over and missed (see Photo 1).

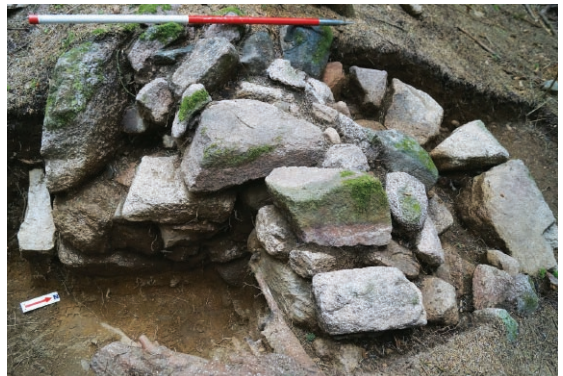
Photo 2. Dog-leg in dyke alignment formed by a hard right angle internally and a rounded corner externally (on right side of picture.)

Trench 9 was a 1x3m trench located across the projected alignment of dyke [C]. The dyke was found to be approximately 1m in width and stood four courses high (approximately 0.95m) on its south side. However, just within the trench, the alignment was interrupted. A right angled turn on the inner face headed north. The outer face of the dyke was given a semi-circular corner rather than a

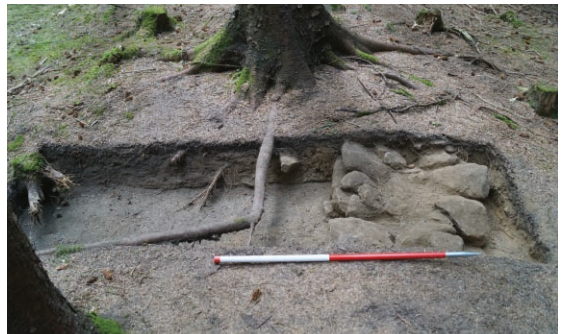
Photo 3. Test Pit 3 with re-aligned dyke.

As noted above, Test Pit 3 was excavated to prove the alignment shown in Trench 9 as well as to confirm that alignment with the remains found in Trench 5. A section of dyke, approximately 0.90m in width and surviving to no more than two stones high, was found where anticipated in line with the adjusted alignment after the dog-leg in Trench 9 (see Photo 3).

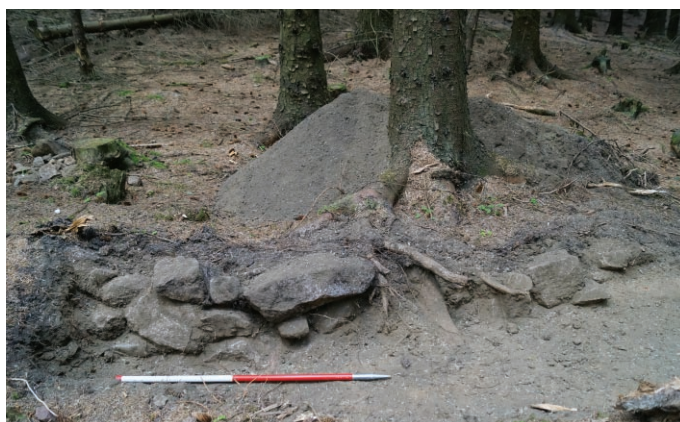
Photo 4. The robbed remains of the dyke in Trench 5.

This confirmed alignment helped in the understanding of the remains in Trench 5. Initially a 1m wide trench was dug along the line of a stone scatter that was thought to have been the continuation of dyke [C]. However, the situation

was not clear-cut owing to the new alignment noted above and the trench was extended several times in order to try to understand the data. The stone scatter appears to have been debris resulting from the robbing of the wall at this corner. The remains of the wall itself was discovered to lie along the new alignment.

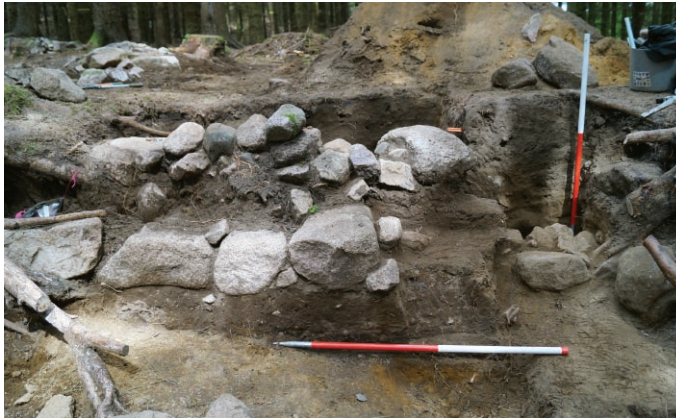
Photo 5. Dyke [N] with [AK] in back right below vertical ranging rod. Note the stones of [N] sitting upon soil build-up between [AK] and the path (below camera).

of soil build-up occurred during the occupation of the site and currently survives to a considerable depth of about 0.90m in this corner of the site. It is unlikely that [AK] stood very high and the evidence suggests a possible herbal or grass border lay between it and the entrance path [Y] (see below). This is suggested by a soil-filled space between feature [AK] and the edge of the path (see Photo 5). Figures 12 and 13 show the soil

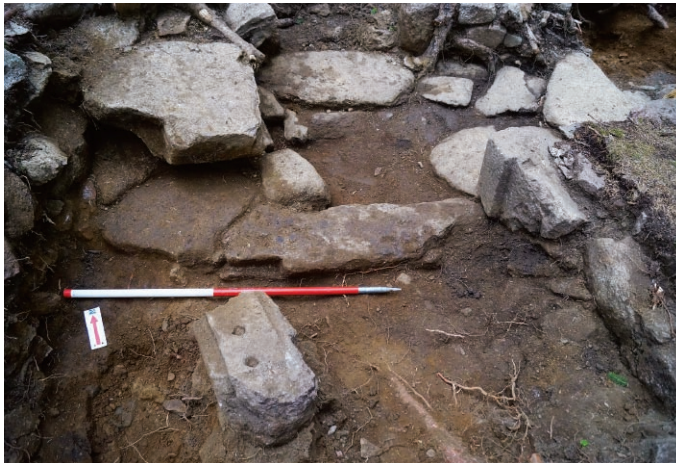
*Photo 6. South internal doorway with door jamb stone on right, window sill with drilled recesses for bars in foreground and threshold stone above ranging rod. At the left side of the threshold can be seen a carved recess, probably associated with wooden door frame furniture.*

The south door jamb was found to have a drilled, horizontal hole. This is presumed to have been for either a door hinge or a dowel for a wooden door

a carved recess (visible in Photo 6) may be indicative of a setting for a timber fitting, possibly to be associated with a door frame construction. But, it should also be noted that this position coincides with the start of the presumed stairs (see below). Timber supports might also be expected here in order to carry the

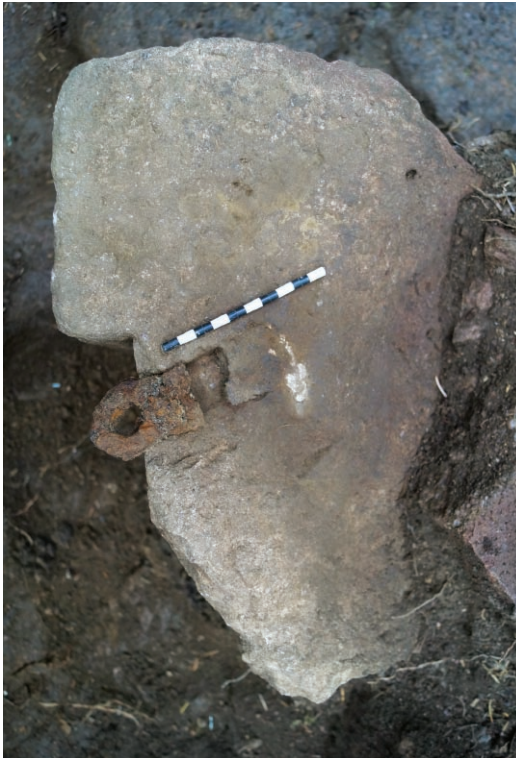
Photo 7. Door jamb showing attached metalwork and carved recess for door.

On the top of the southern inner door jamb stone was a dovetailed recess with rusted metal found still to be *in situ*. Part of a metal eye-pivot hinge was recovered from the midden area (Trench 13) located near to the entrance to the dwelling in context (617). This fitted precisely into the recess on the stone (see Photos 6 and 7). If this was the method used for hanging the door, the drilled holes would seem more likely to have been used for mounting a wooden door frame to act as a draught excluder for the closed door to sit against.

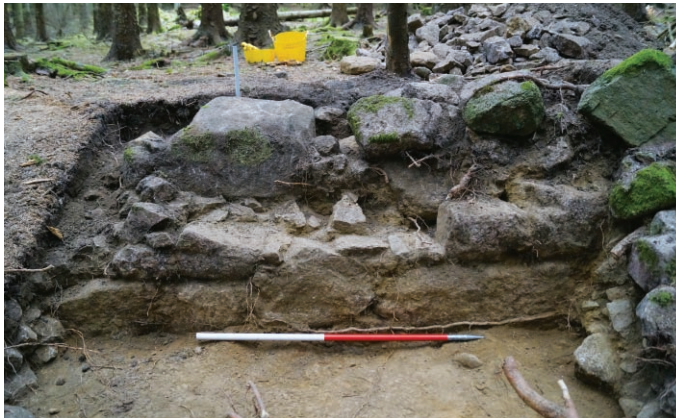
Photo 8. Back wall [H] of building.

courses high on its west-facing side (see Photo 8). The lowest stones of the wall lay directly onto the hard, natural subsoil with re-deposited soft natural subsoil abutting the wall. No cobbled flooring was found in this part of the room.

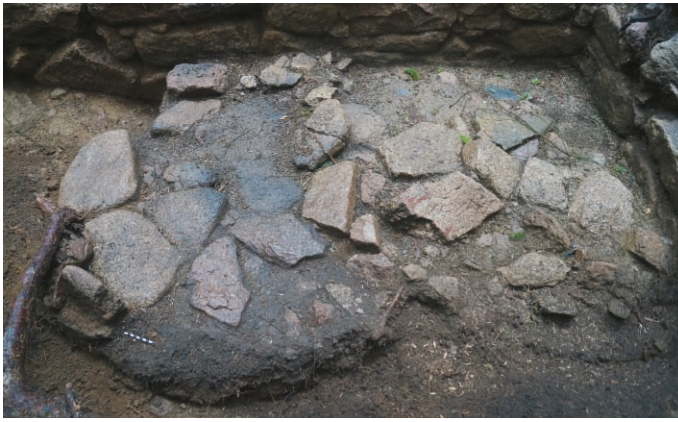
Photo 9. Hearth setting with worked stone at bottom left by root.

On the floor of this room was found hearth [K] lying on top of the floor cobbles and containing burnt material (see Photo 9). Plaster/mortar fragments had fallen on top of this hearth. Also noted were ephemeral traces of a possible

Also of interest was the recovery of three, worked stone fragments. One of the fragments was recovered from around the hearth [K] (see Photo 9) but is thought likely to have originated elsewhere. It may also be worth noting that a fourth similar fragment was found amongst the stones of dyke [D] in Trench 14. The pieces appear reminiscent of parts of a water trough, though this is speculative.

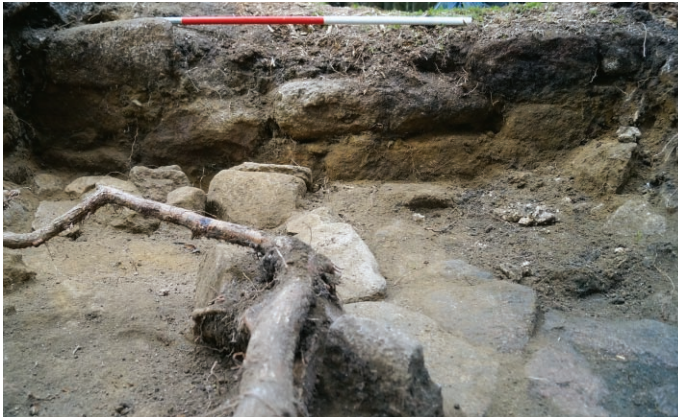
Photo 10. Possible black soot marks on wall stones behind hearth stones.

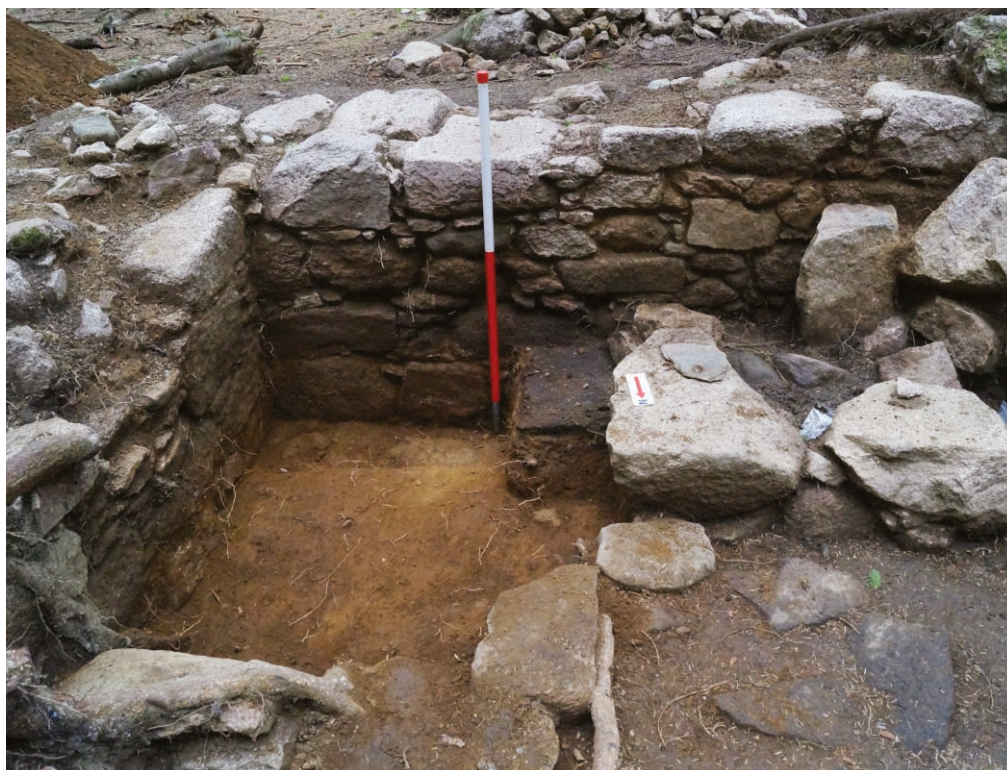
*Photo 11. Trench 6 at the south end of the building. In the corner can be seen the original floor level and, next to the ranging rod, a small baulk showing the occupation layers topped by a peat deposit. This peat store is considered to have been associated with the secondary hearth stones seen bottom right. Behind these stones is a platform that may have been the site of an earlier hearth.*
